# SIKA AT WORK

## REHABILITATION OF THE LOCSIN MONTELIBANO HOSPITAL, PHILIPPINES

STRENGTHENING: Sika® Carbodur®

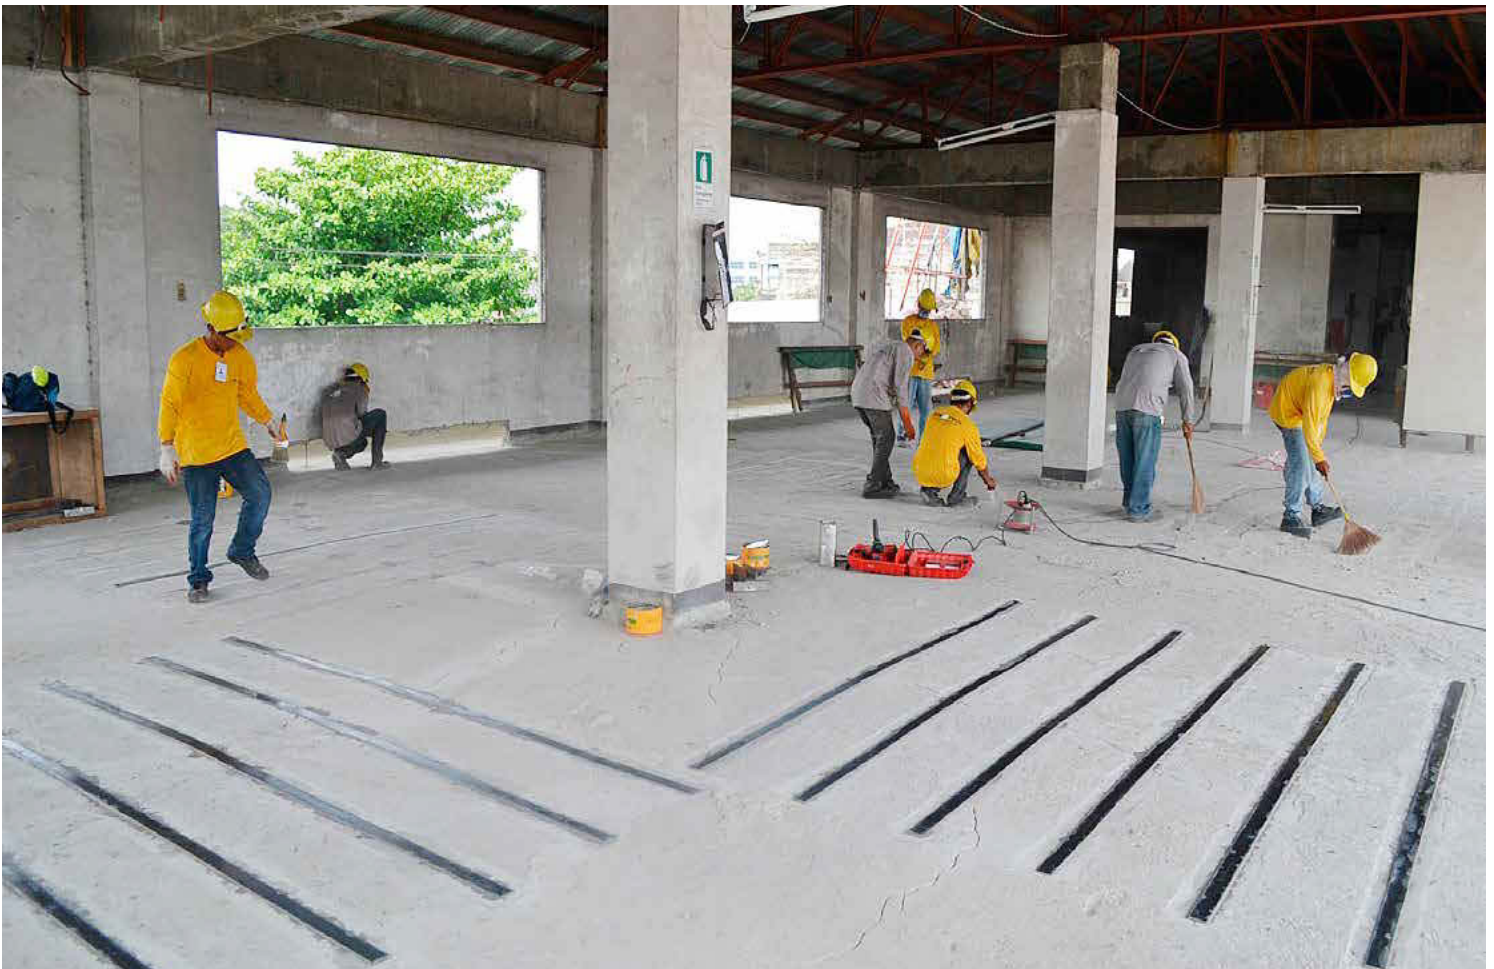
Approximately 70 mm of the surface plaster and topping were stripped off from the suspended slab. The crack concrete slab was repaired through crack injections with the use of Sikadur® 752. Due to the width of the cracks, they were easily filled by gravity feed.

Epoxy adhesive was applied to the prepared surface edge in order to level the surface overlay using Sikadur® 31 CF.

Sika® CarboDur® S512 was installed to the concrete slabs to strengthen and compensate additional cracking and stresses of the structure

Finally, concrete mortar and topping was applied to overlay and protect the Sika® CarboDur® plates as well for aesthetic purposes.
