Roof Strengthening

Garage Roof, Soazza, Switzerland

Structural Strengthening: **Sika® CarboDur® Plates**
Near Surface Mounted System
(NSM)

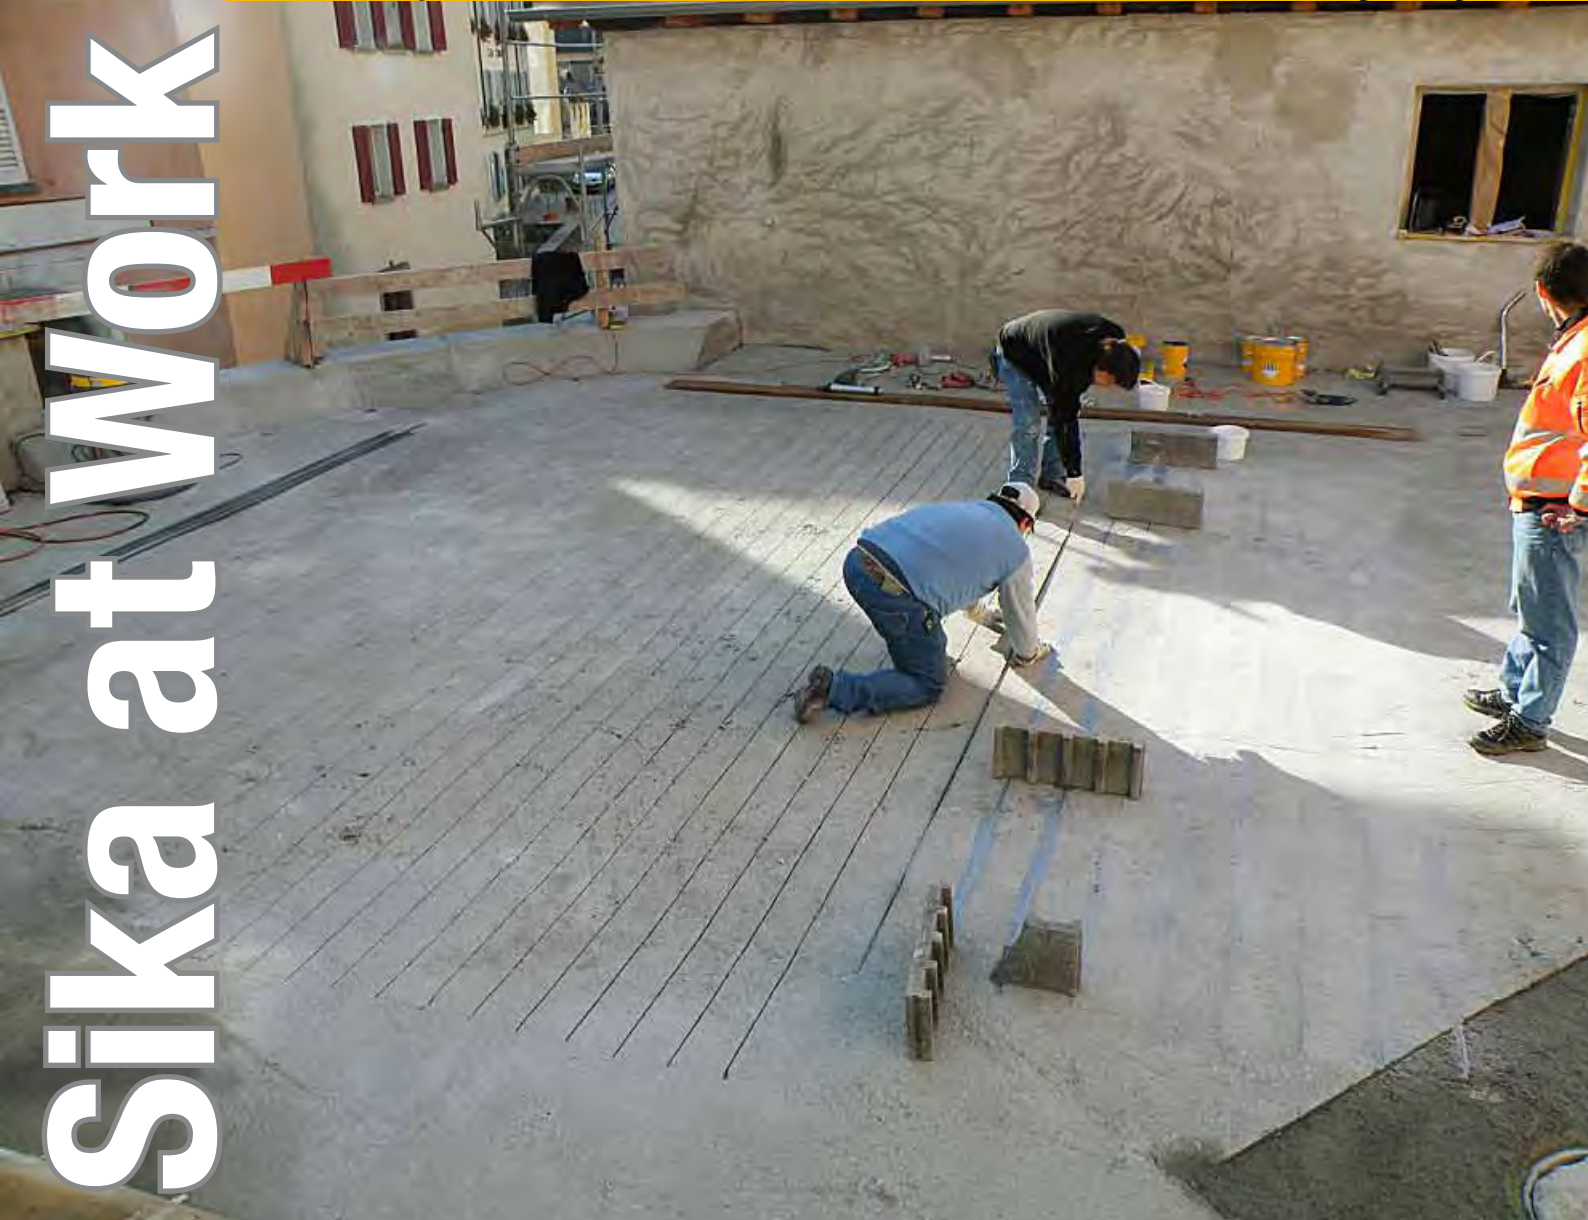
Strengthening system to replace missing steel reinforcement in top concrete slab (garage roof), which can be installed in weak, cracked concrete.

The Sika **CarboDur**[®] Near Surface Mounted system was used to strengthen the garage roof, using **Sika CarboDur S 1.525 Plates** and **Sikadur[®]-330** adhesive. The plates are embedded into slits in the concrete substrate. This application requires no surface preparation and reduces the risk of delamination compared to regular surface mounted **CarboDur[®] Plates**. Being embedded in the resin, the **CarboDur[®] Plates** are protected sufficiently. After the installation of the strengthening system, the roof can again be used as before.
