COLONNADE BRIDGE ROOF RENOVATION IN PIEŠŤANY, SLOVAKIA

ROOFING: Sikalastic® MTC

COLONNADE BRIDGE ROOF RENOVATION

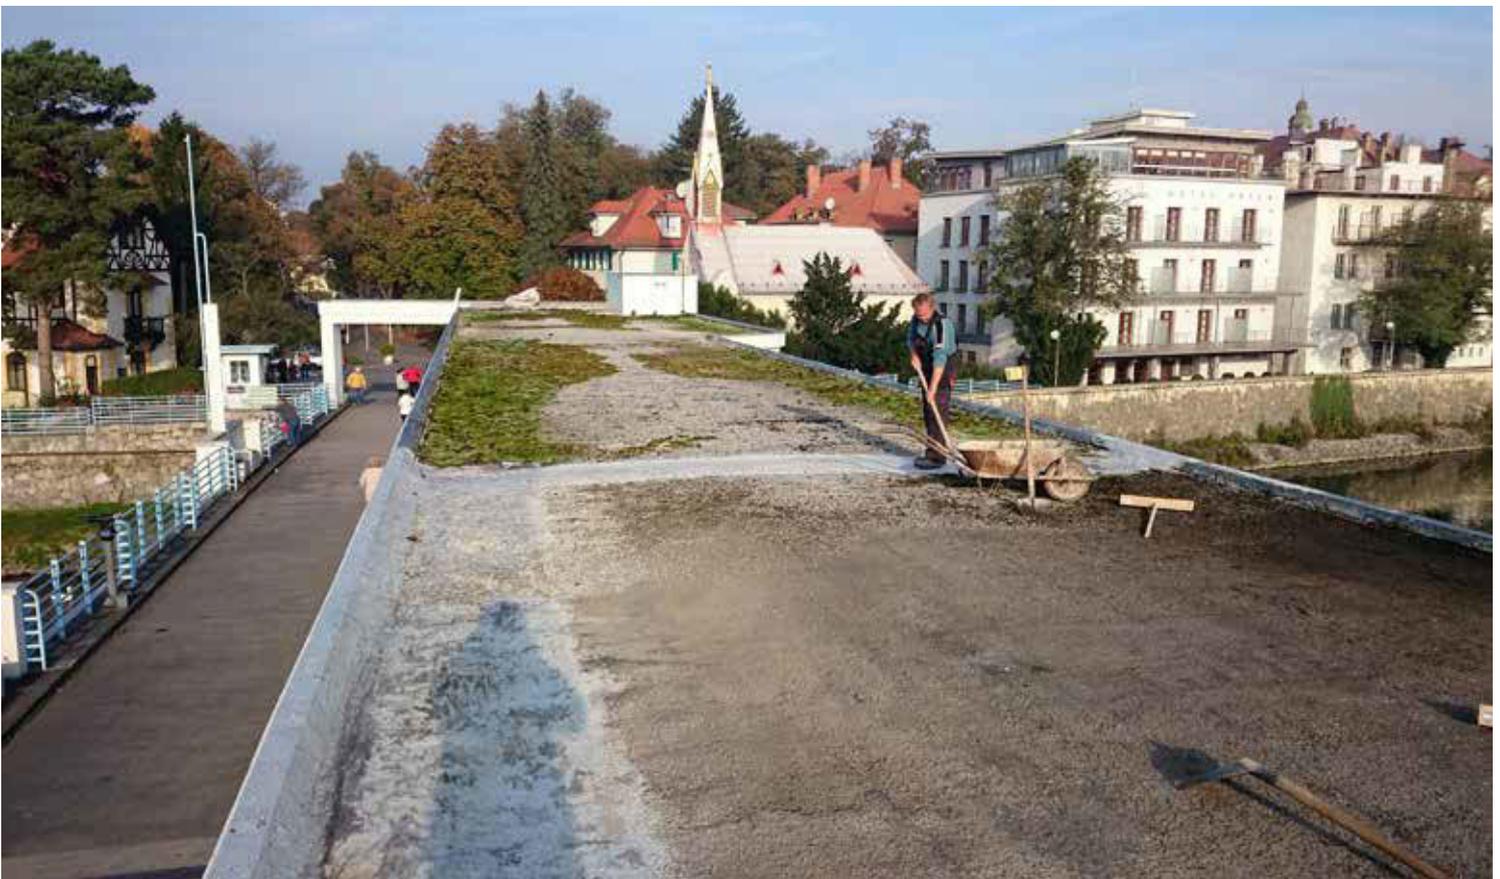
Time wore away at the bridge, and the roof began to leak. The roof was damaged, and some parts were overgrown with moss. After cleaning the moss off the roof, the remaining surface was so uneven it required a simple bituminous sheet. With an even, solid and clean surface, it was prepared for the application of the roofing waterproofing system Sikalastic® MTC.

The applicator spread the first layer of Sikalastic®-614 by roller and immediately pressed fresh reinforced glass fabric Sika® Reemat Premium into it. After allowing time to cure, the applicator checked it, cut any protruding fibers and applied the second coat of Sikalastic®-614.
