Project Profile

Brinker, Hedgcoxe and Daffron Elementary Schools
Plano, TX

Sarnafil Décor Roof System, using 60 mil, G410 membrane in light gray

Wanted: A Roofing Solution That Makes the Honor Roll

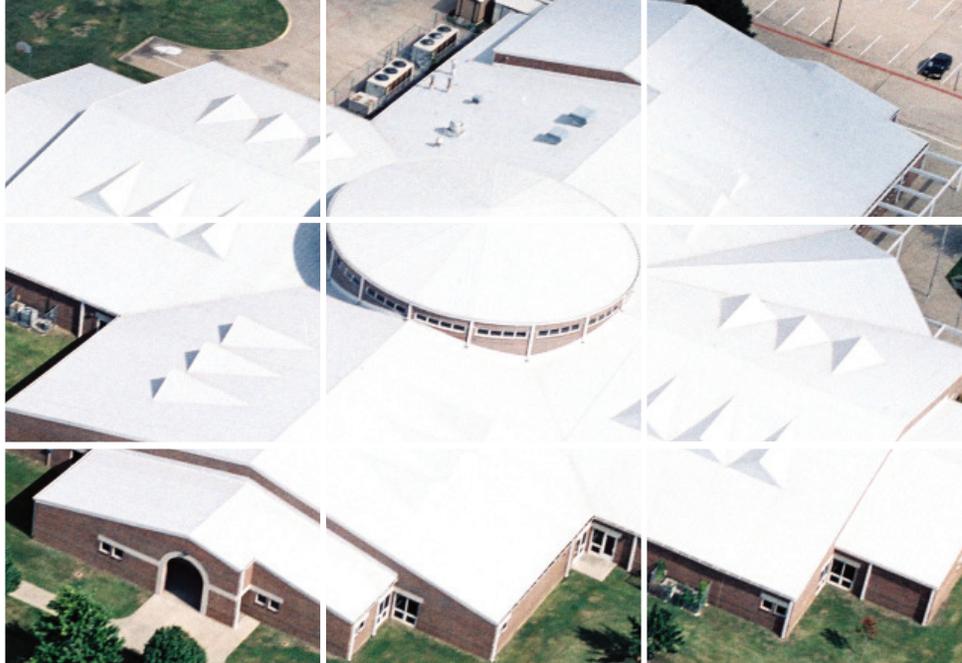
Sarnafil Décor Roof System in Plano, TX

In the end, Benchmark recommended the Sarnafil Décor Roof System to the Plano School District as an option that would allow the roof to look like metal, but provide the leak-tight security of hot-air welded thermoplastic. The Décor system consists of rib-like extruded “profiles” that are hot-air welded to the colored Sarnafil membrane. The profiles are installed on-site by the roofing contractor to exactly replicate the positioning and appearance of the standing seams of an architectural metal roof.

The installation began in May, 2002, after classes were dismissed for summer vacation. The shingles were torn off and any deteriorated or wet insulation boards were removed. New boards were installed as needed, and all boards were fastened to meet current FM requirements. Foam adhesive was used to install the 1/4” Dens-Deck® Roof Guard over the OSB to provide a smooth substrate. Then the Sarnafil membrane was adhered to the Dens-Deck. No additional insulation or underlayment was used. “We felt the existing roof was sufficiently insulated, and the reflectivity of the light-gray colored Sarnafil membrane
